SAFETY ADVISORY BULLETIN 00-01

THE IMPORTANCE OF IDENTIFYING AND ADDRESSING ROOT CAUSES OF EQUIPMENT MALFUNCTIONS

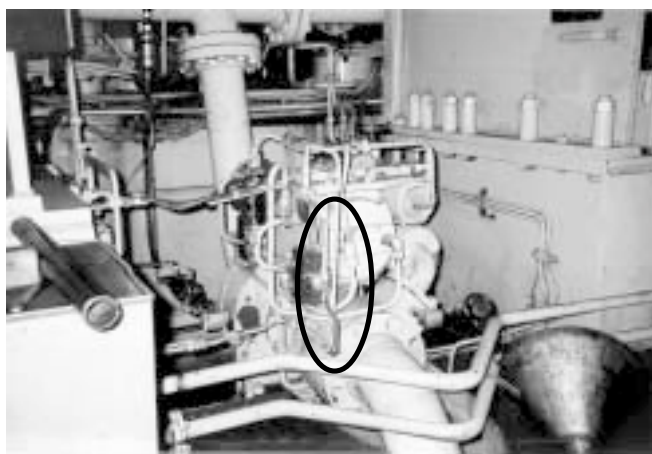
Main engine starting air valve that malfunctioned. Note modification indicated by the unpainted copper tubing (circled).
